LIGONIER DAM

NDI No. PA 00477
PennDER No. 65-117

PHASE I INSPECTION REPORT
NATIONAL DAM INSPECTION PROGRAM

March 1980

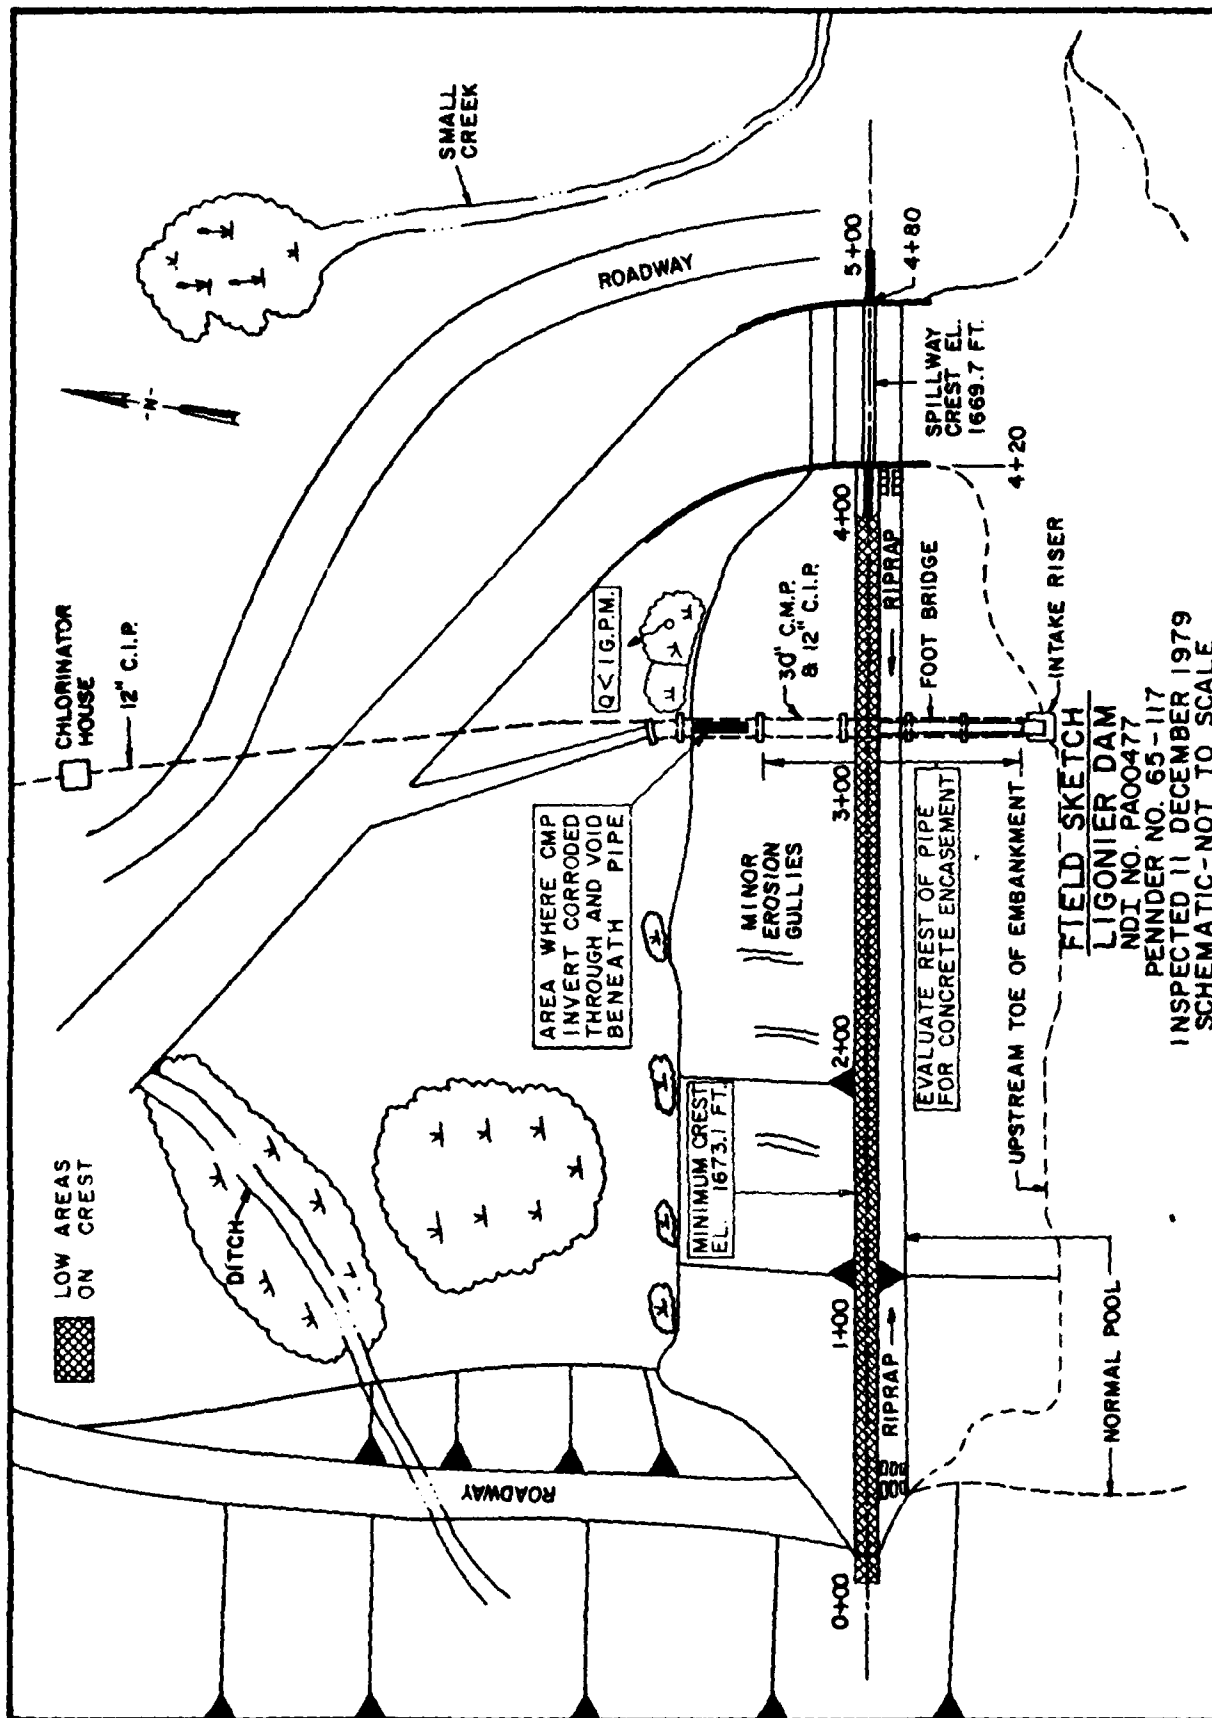
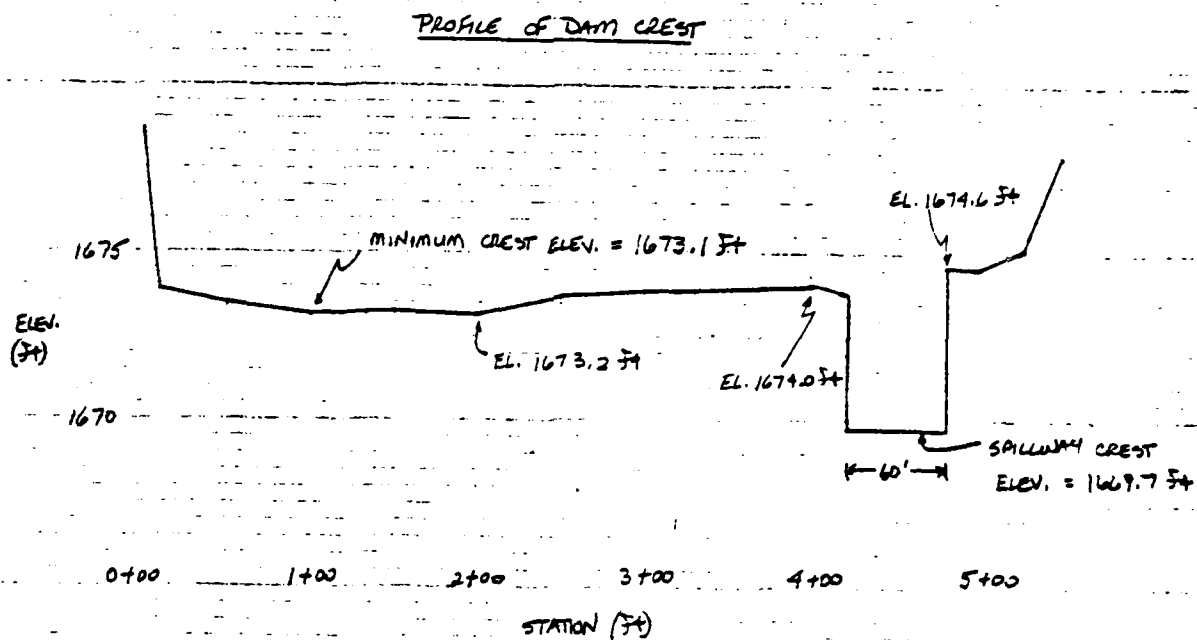
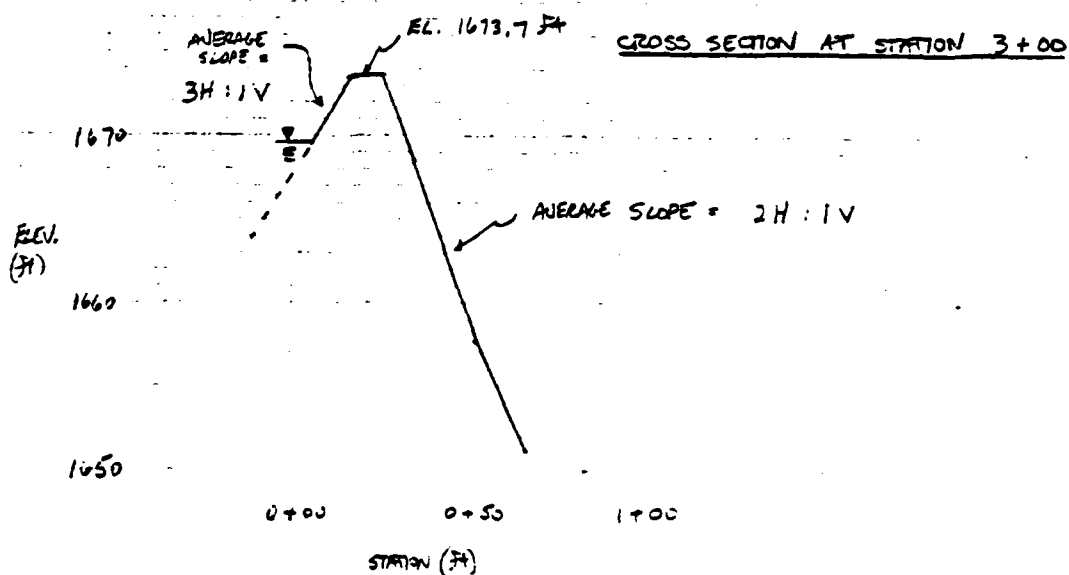
LIGONIER DAM
TOP OF DAM PROFILE
TYPICAL CROSS-SECTION

VISUAL EXAMINATION OF	OBSERVATIONS	REMARKS OR RECOMMENDATIONS
VERTICAL AND HORIZONTAL ALIGNMENT OF THE CREST	Visual inspection of the horizontal alignment indicated no problems. The top of dam profile (Appendix D) shows that the left section of the embankment is low. Elevations of the dam crest range from 1674.5 ft. M.S.L. on the right side of the embankment to a minimum of 1673.1 ft. M.S.L. at Station 1+00.	The top of dam elevation should be restored to the original design Elevation of 1674.5 ft. M.S.L.

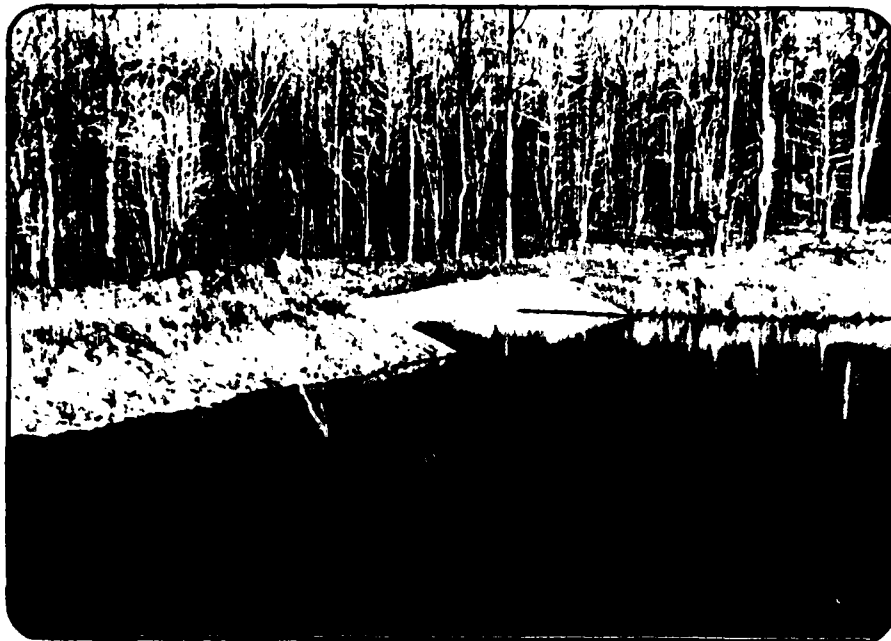
PHOTO 3. View of the Entrance to the Spillway from the Gate Tower

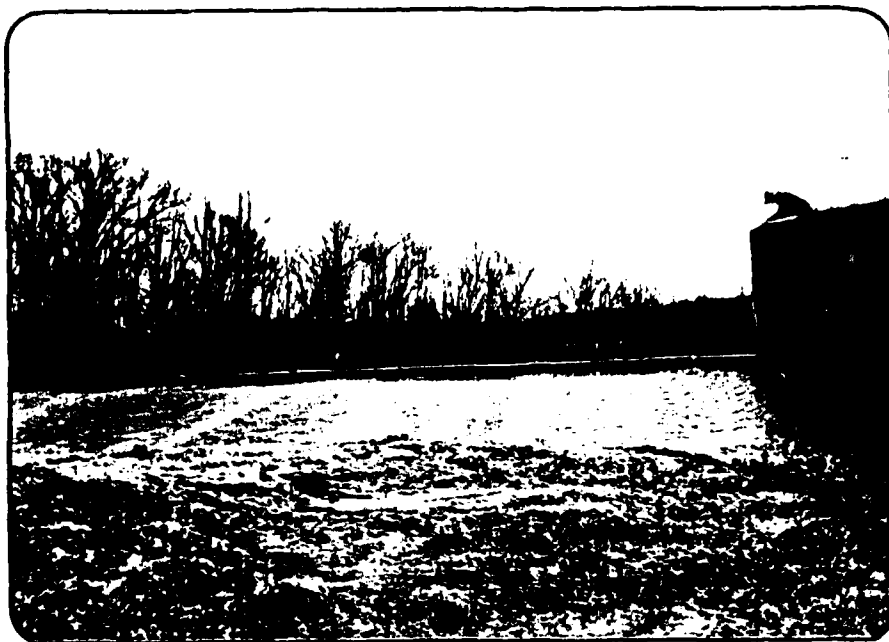
PHOTO 5. View Looking Upstream at the Crest of the Spillway

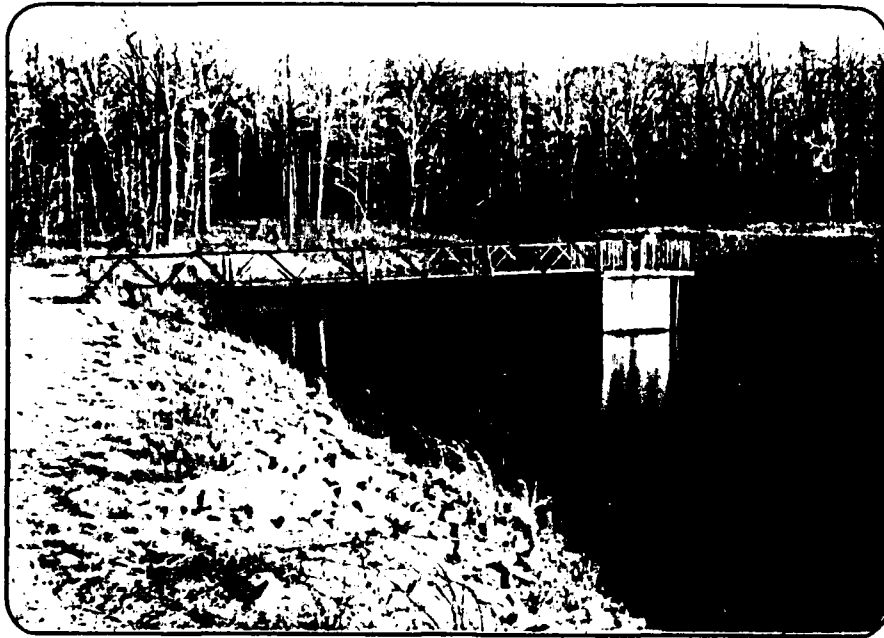
PHOTO 7. View of the Gate Tower

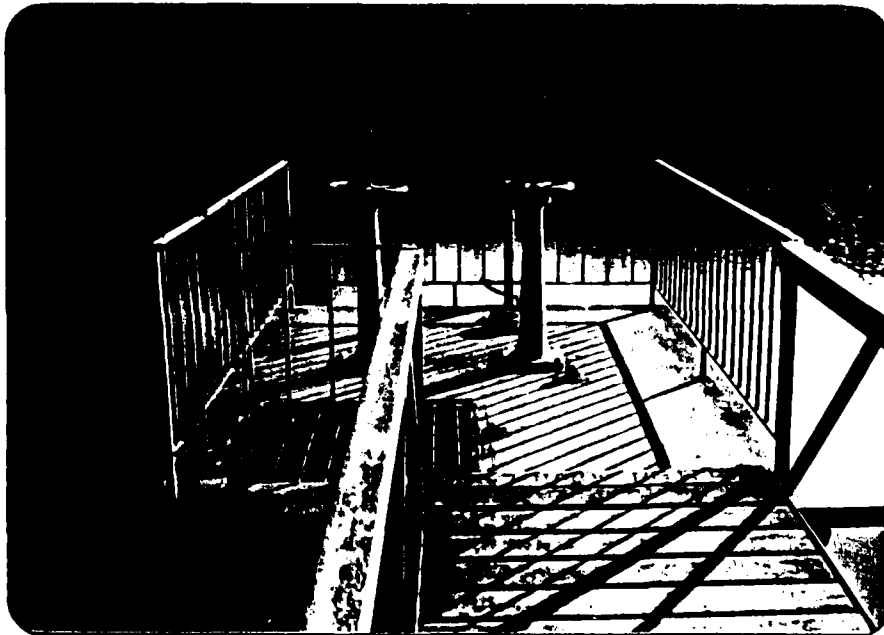
PHOTO 8. View of the Control Valves on the Gate Tower
